EROSION AND SLOPE STABILITY MONITORING PLAN

Great Sacandaga Lake
FERC PROJECT No. 12252-NY

Gomez and Sullivan Engineers, P.C.
Engineers and Environmental Scientists
288 Genesee Street
Utica, New York 13502

January 2004

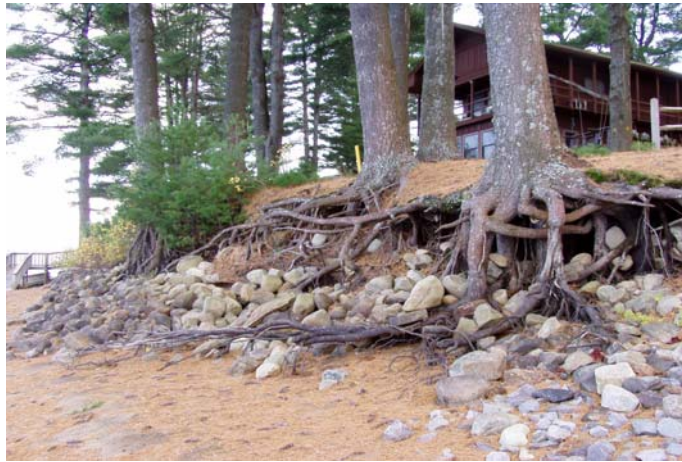
Severe erosion site, highest repair priority (Severe, 1). Ranked 1 due to proximity to taking line and structures.

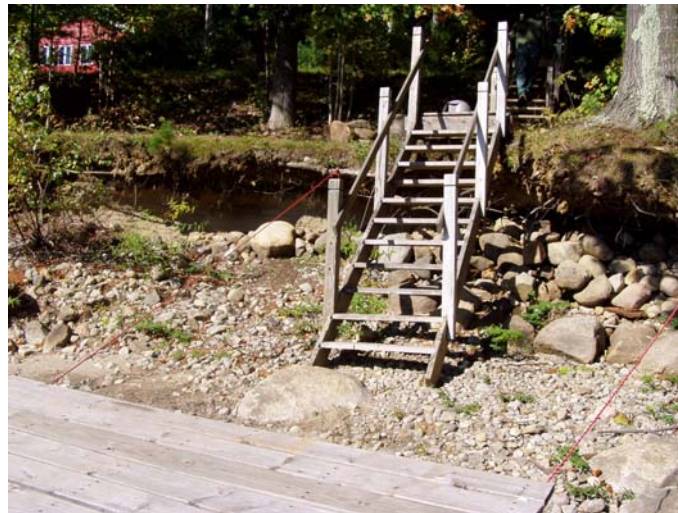
Severe erosion site, median repair priority (Severe, 2). Ranked 2 due to proximity to taking line and structures (moderate distance).

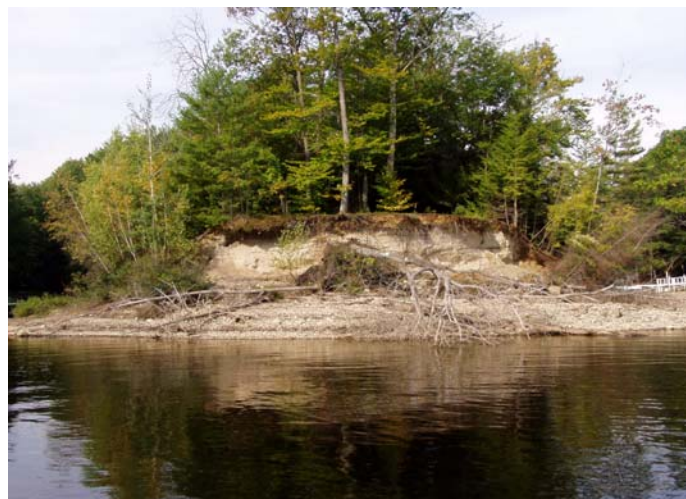
Severe erosion site, lowest repair priority (Severe, 3). Ranked 3 due to proximity to taking line and structures (far away).

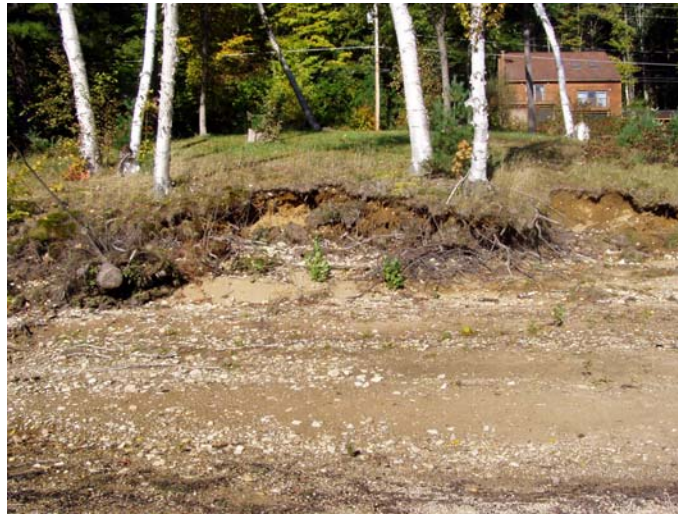
Moderate erosion site, highest repair priority (Moderate, 1).
Ranked 1 due to proximity to taking line and structures.

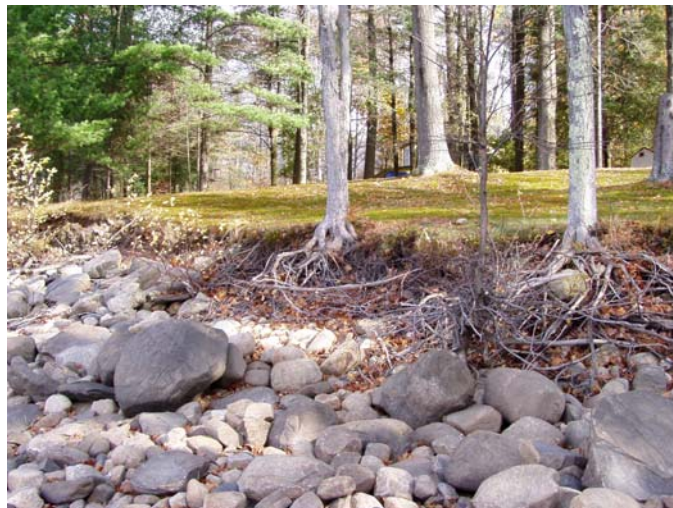
Moderate erosion site, median repair priority (Moderate, 2)
Ranked 2 due to proximity to taking line and structures
(moderate distance).

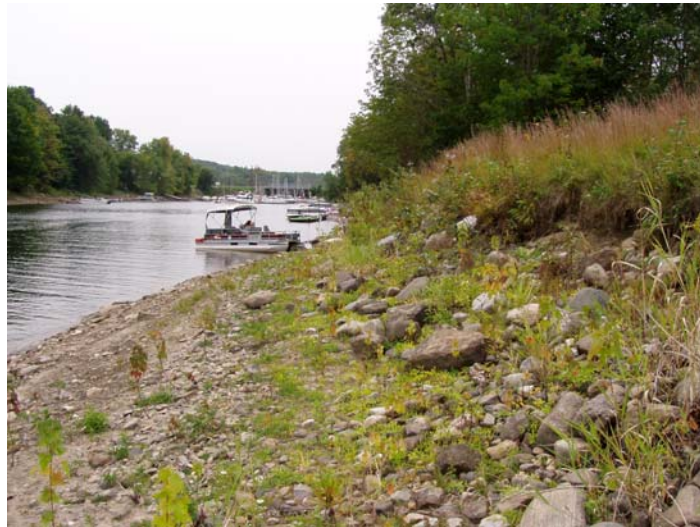
Moderate erosion site, lowest repair priority (Moderate, 3)
Ranked 3 due to distance to taking line and structures (far away).

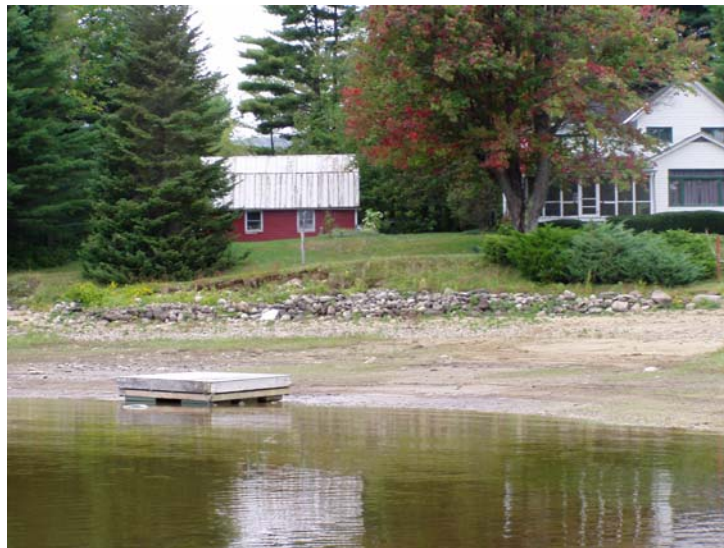
Site classified as having Low erosion activity. Note prior rip rap repairs with vegetation immediately above indicating erosion is not currently actively occurring at this location.
