EROSION AND SLOPE STABILITY MONITORING PLAN

Great Sacandaga Lake
FERC PROJECT No. 12252-NY

Gomez and Sullivan Engineers, P.C.
Engineers and Environmental Scientists
288 Genesee Street
Utica, New York 13502

January 2004

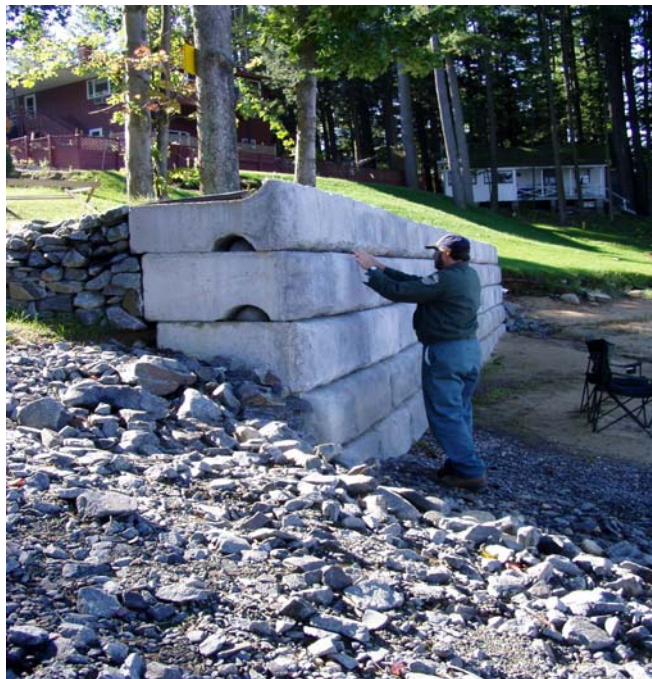
Concrete bin wall under construction by permit holder for shoreline protection.

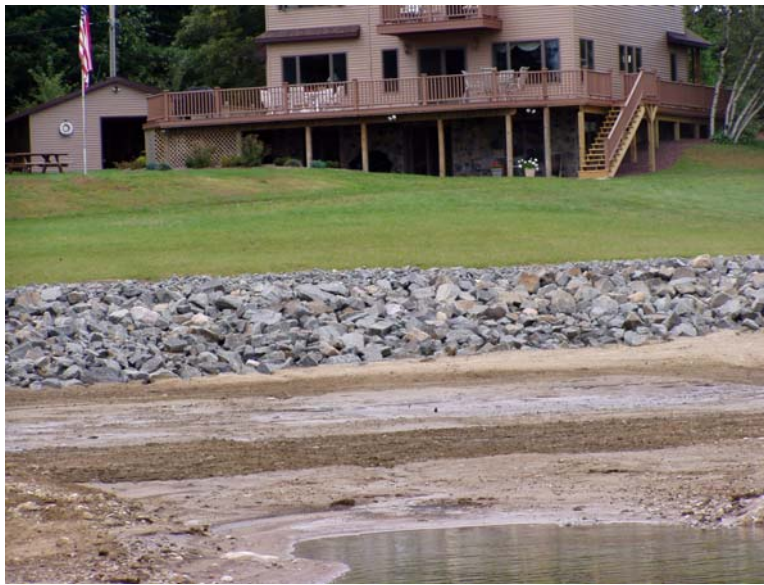
Rip rap placed by permit holder for shoreline protection.

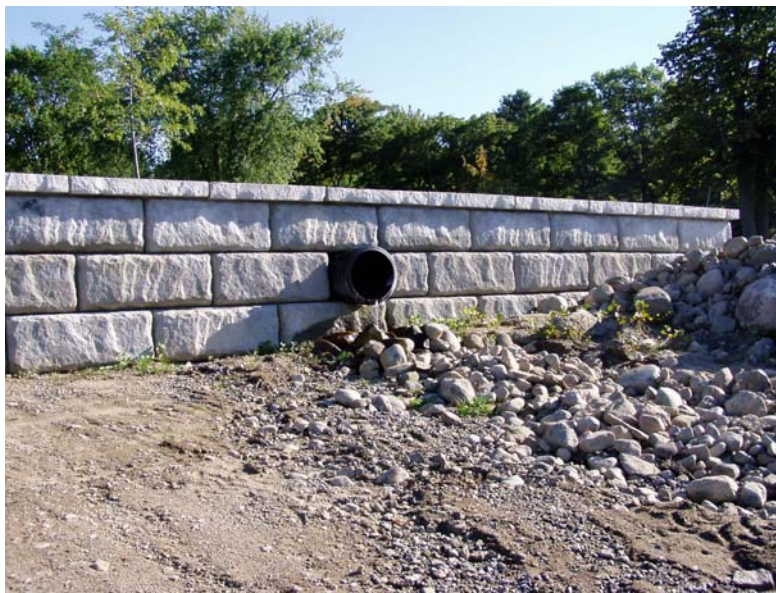
Concrete bin wall constructed by permit holder for shoreline protection.

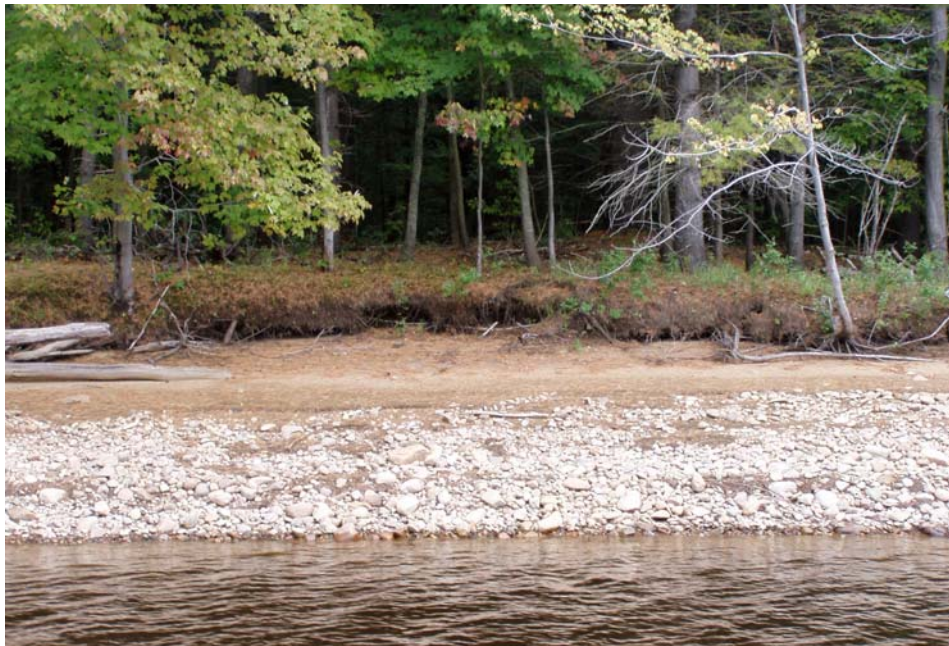
P062

Town of Hope	N.A.	N.A.	N.A.	Photo only	62, 63	WB	3	9/25/03	761.3		Sandy bank, furthest reach inspected upstream of Northville Bridge, rated low priority as there is currently no encroachment on private property or road, will need stone
Hunter Creek Bay	N.A.	N.A.	N.A.	Photo only	80	WB	3	9/26/03	761.3		Downstream slope of Embankment at Hunters Creek Dam. Rip rap generally in good condition, although upper 2 ft. band may need touch up.
Mayfield Northhampton Line	M. McEntee	4896	159A	Y	2, 4	Land	3	9/22/03	761.2		Photo showing area with minor erosion near the high water level only
Inside Woods Hollow	Near Partyka	NA	849	Photo only	41	WB	3	9/24/03	761.3		Long reach with some bluff erosion, low priority, long way from taking line, work boat, will need stone, long way from take line
Edinburg	Heck	7218	303	Y	77	Land	3	9/26/03	761.3		Sandy Soil, erosion of high water level, check on access

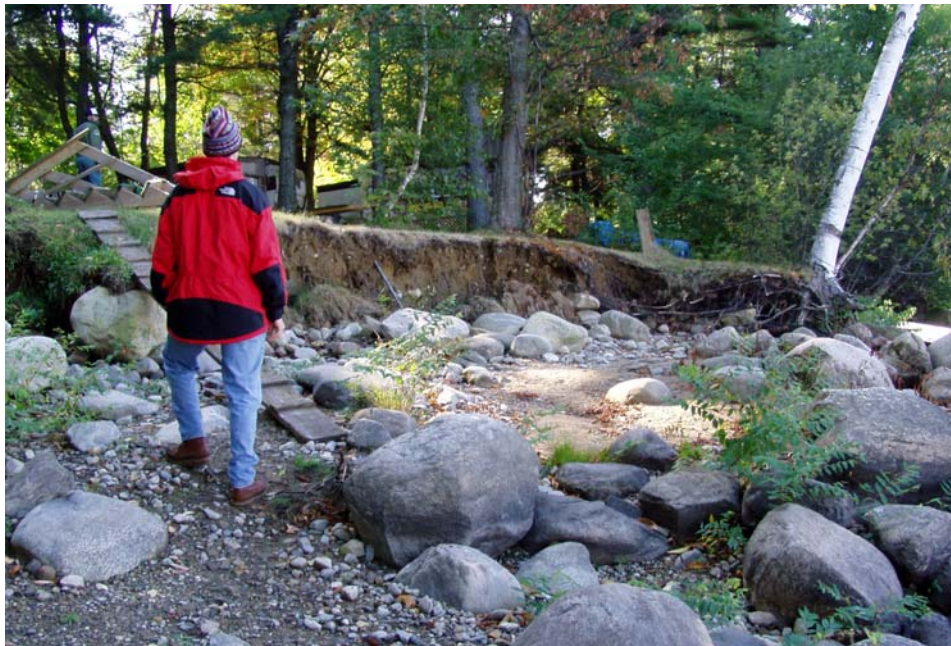
P070

Brooks Bay	T Nyland	12251	70	Photo only	126	WB	1	10/9/03	762.2		Site adjacent to repair work done by HRBRD Is 2003, this site should be done in 2004, sandy soil, some stone available, will need stone, work boat access
South Shore Road near Dam	W Trellak	14535	48	Y	130	WB	1	10/9/03	762.2		Sandy bank with foam and moss cover, bank height 3' - 5', encroachment on road in some areas, some stone available, will need more, work boat access, sites should be done together
South Shore Road near Dam	G Watson	14752	48	Y	130	WB	1	10/9/03	762.2		
North Shore Road	J Duffy	11996	17	Photo only	131	WB	2	10/9/03	762.2		Boney sand, undercut trees with exposed roots, trees will need to be trimmed, existing rip rap needs to be raised, will need stone, work boat access, sites should be done together
North Shore Road	R Johnson	10035	43	Photo only	131	WB	2	10/9/03	762.2		
North Shore Road	D Robinson	14910	37/41	Photo only	132	WB	2	10/9/03	762.2		Sandy bank, erosion height up to 10', some stone available, need more stone, raise rip rap to accommodate high water level, work boat access, sites should be done together

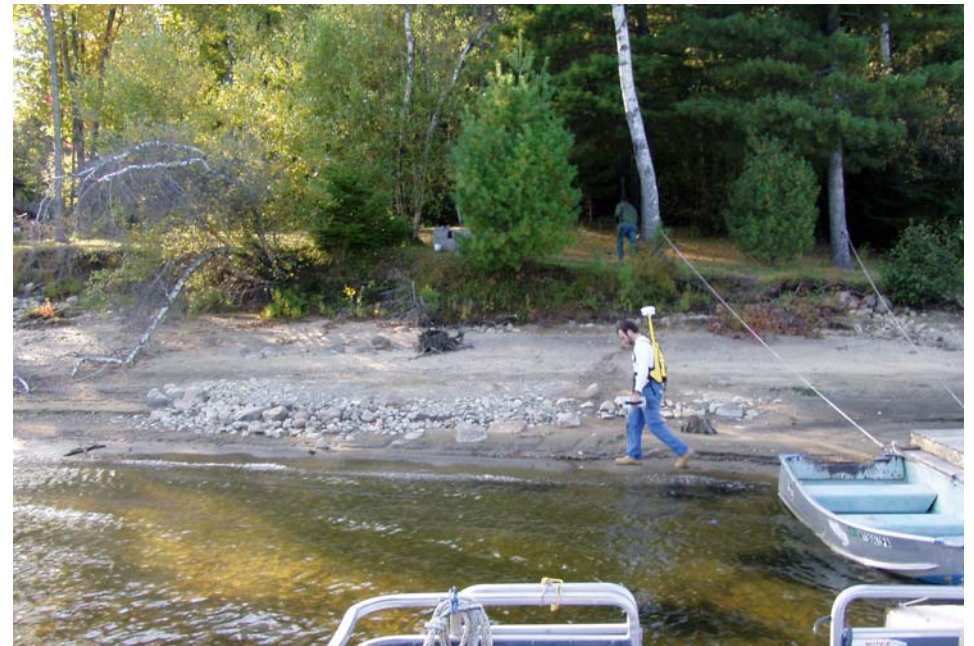
P103

Edinburg - North Shore Road	D Groat	6087	293	Photo only	103	None Req'd.	Watch	10/8/03	762.3		Permittee will be doing repairs, eroded bank on left side of photo, no work done yet
Mayfield	R & M Marshall	13925	1056	Y	1, 3	None Req'd.	None	9/22/03	761.2		Bay near HRBRRD Office - Rip Rap, Example of Permittee Repair. Good
Edinburg	Robichard	13208	299	Y	76	None Req'd.	None	9/26/03	761.3		Work done Summer 2003 by HRBRRD. Good repair
