Figure 7-10
Old Forge Dam
Emergency Action Plan
Dam Failure Inundation Limits
"Stormy Day" Scenario

Dam Breach Study

Old Forge Reservoir Dam

STATE OF NEW YORK
BLACK RIVER REGULATING DISTRICT
OLD FORGE RESERVOIR
REBUILDING OF SPILLWAY

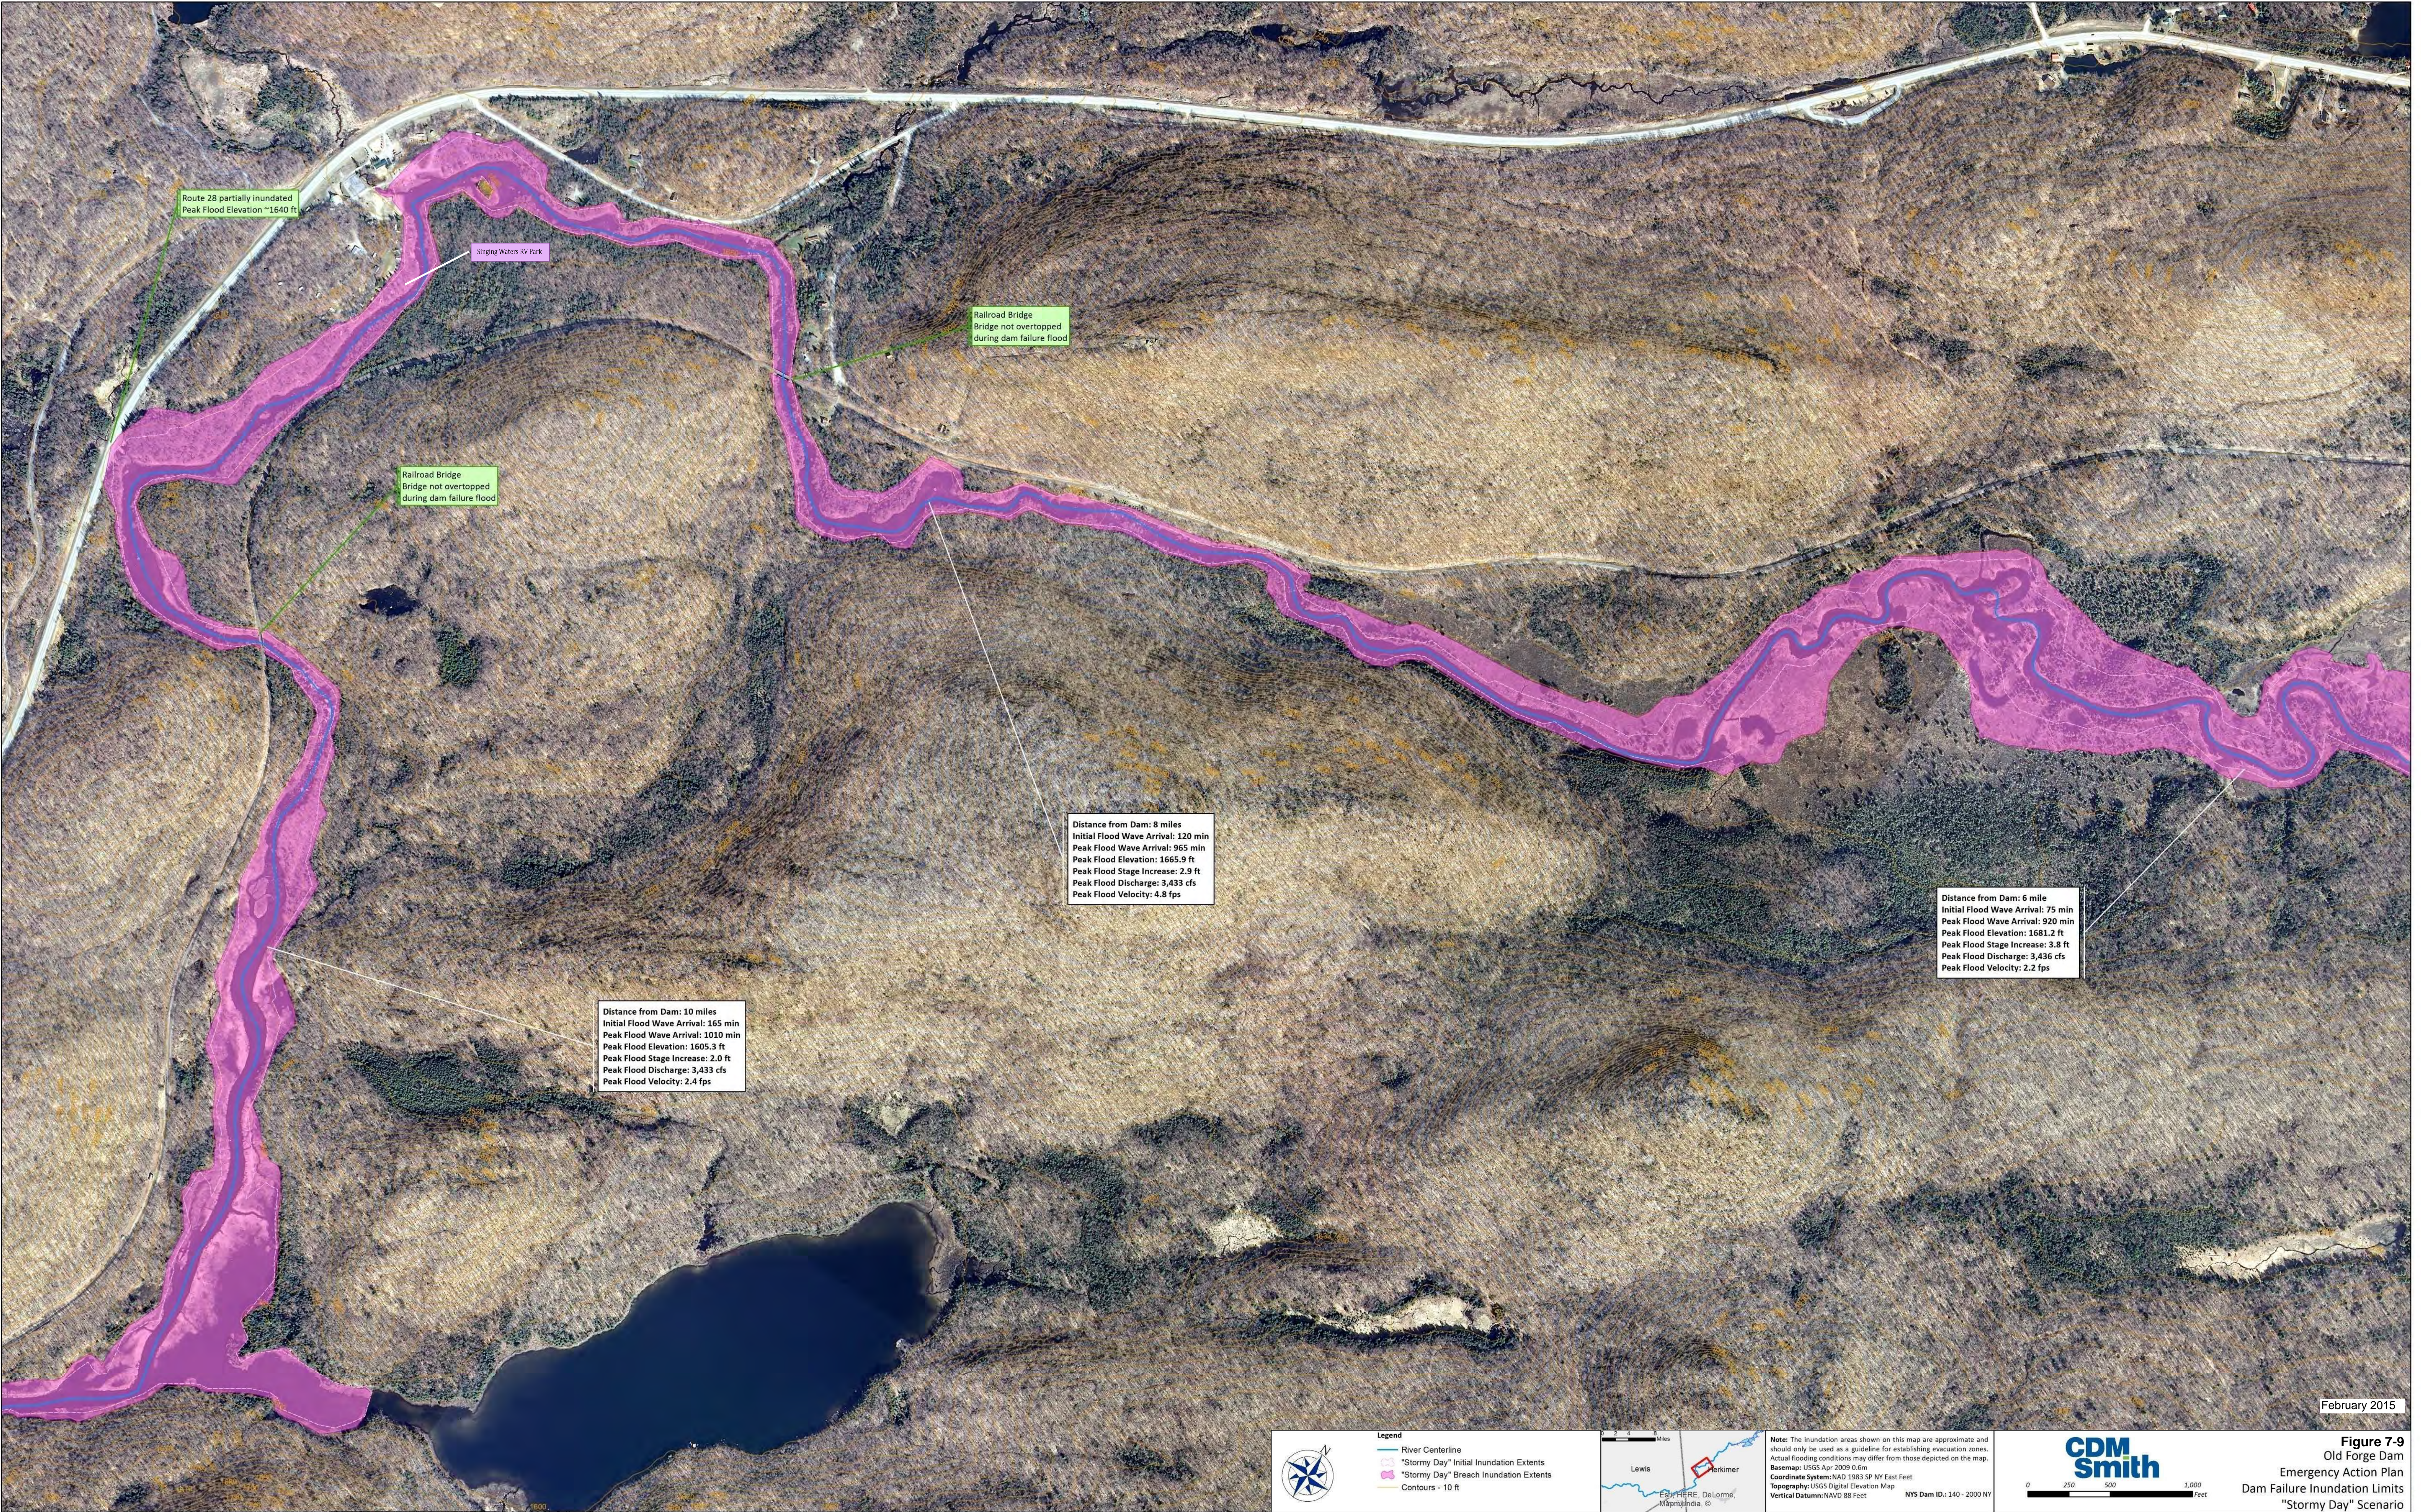
Route 28 partially inundated
Peak Flood Elevation ~1640 ft

Railroad Bridge
Bridge not overtopped
during dam failure flood

Distance from Dam: 8 miles
Initial Flood Wave Arrival: 120 min
Peak Flood Wave Arrival: 965 min
Peak Flood Elevation: 1665.9 ft
Peak Flood Stage Increase: 2.9 ft
Peak Flood Discharge: 3,433 cfs
Peak Flood Velocity: 4.8 fps

Distance from Dam: 10 miles
Initial Flood Wave Arrival: 165 min
Peak Flood Wave Arrival: 1010 min
Peak Flood Elevation: 1605.3 ft
Peak Flood Stage Increase: 2.0 ft
Peak Flood Discharge: 3,433 cfs
Peak Flood Velocity: 2.4 fps

Distance from Dam: 6 mile
Initial Flood Wave Arrival: 75 min
Peak Flood Wave Arrival: 920 min
Peak Flood Elevation: 1681.2 ft
Peak Flood Stage Increase: 3.8 ft
Peak Flood Discharge: 3,436 cfs
Peak Flood Velocity: 2.2 fps

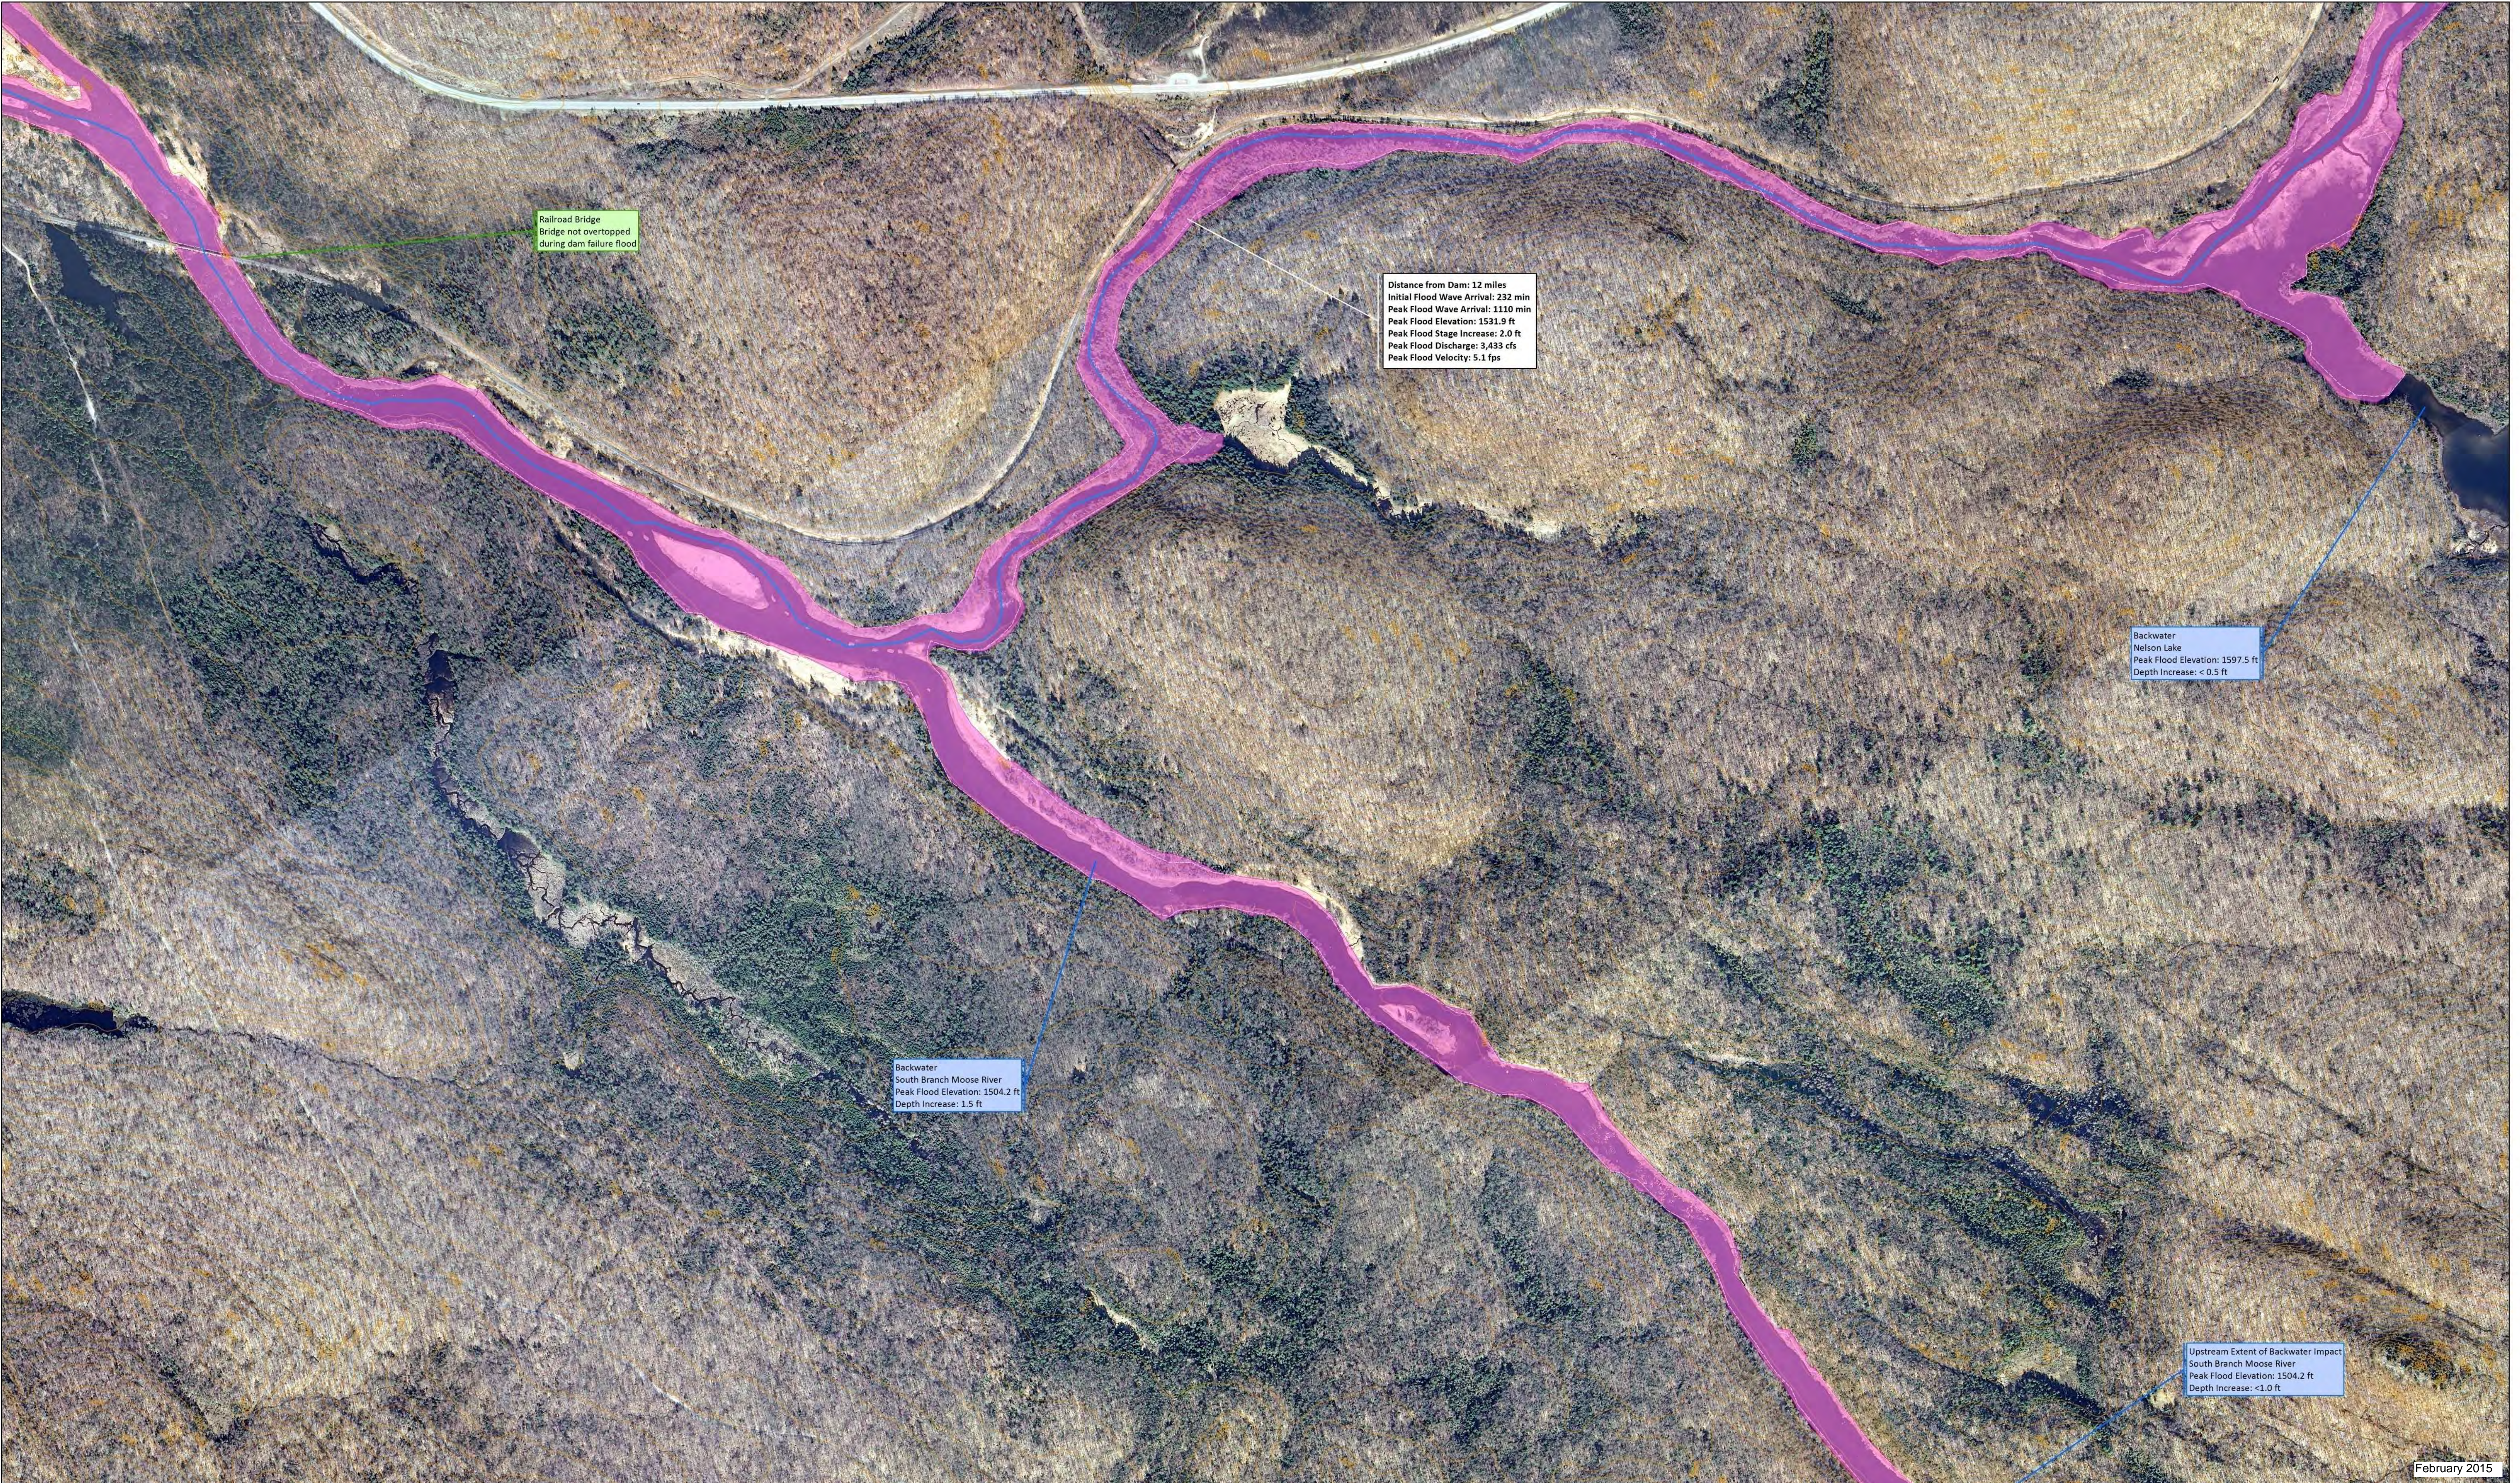
Railroad Bridge
Bridge not overtopped
during dam failure flood

Distance from Dam: 12 miles
Initial Flood Wave Arrival: 232 min
Peak Flood Wave Arrival: 1110 min
Peak Flood Elevation: 1531.9 ft
Peak Flood Stage Increase: 2.0 ft
Peak Flood Discharge: 3,433 cfs
Peak Flood Velocity: 5.1 fps

Backwater
Nelson Lake
Peak Flood Elevation: 1597.5 ft
Depth Increase: < 0.5 ft

Backwater
South Branch Moose River
Peak Flood Elevation: 1504.2 ft
Depth Increase: 1.5 ft

Upstream Extent of Backwater Impact
South Branch Moose River
Peak Flood Elevation: 1504.2 ft
Depth Increase: <1.0 ft
