Hudson River - Black River Regulating District

Emergency Action Plan

Sixth Lake Dam

Hazard Classification: Class C, High Hazard
N.Y.S. D.E.C. Dam Safety Id. No. 140 – 0860
National Dam Id. No. NY00318
Latitude 43° 33' 00" N., Longitude -74° 45' 00" W.
Vertical Datum: NGVD 1929

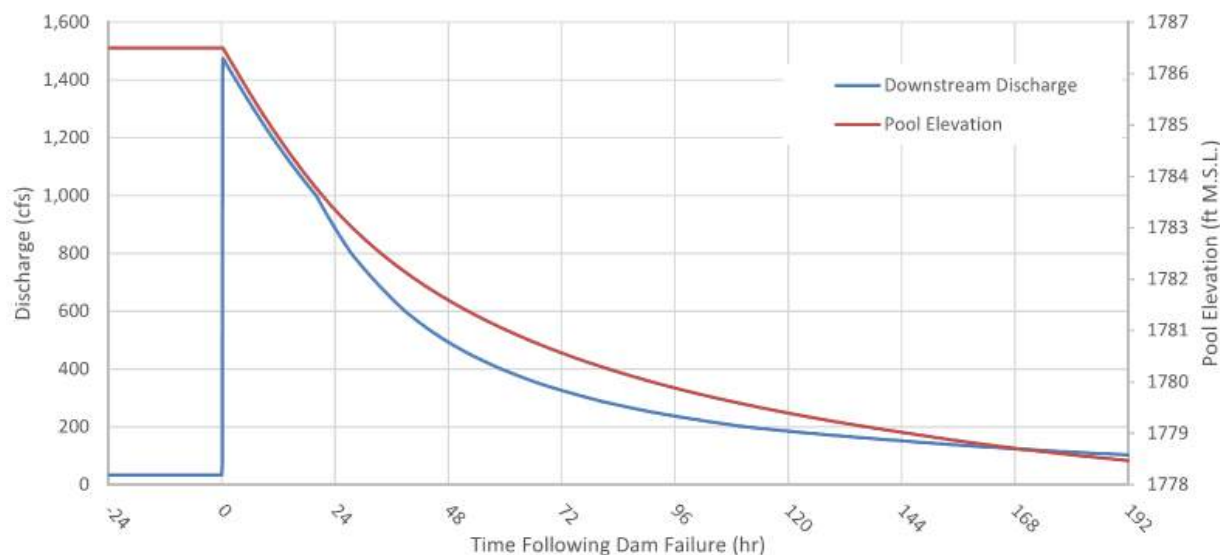
Figure K.4 – “Sunny Day” Dam Failure Hydrograph and Pool Elevation at Sixth Lake Dam Site

At the Sixth Lake Dam, the “sunny day” failure produces a peak discharge of 1,475 cfs within 15 minutes of the start of the failure. Following this peak, the discharge recedes as the Sixth Lake and Seventh Lake pools drain through the breach opening, a process that takes a day and a half to reduce the discharge by half, and four days for the reservoir to drop by just 6.0 feet. **Figure K.4** shows the dam breach hydrograph at the site of the failed dam and the corresponding reservoir pool elevation.

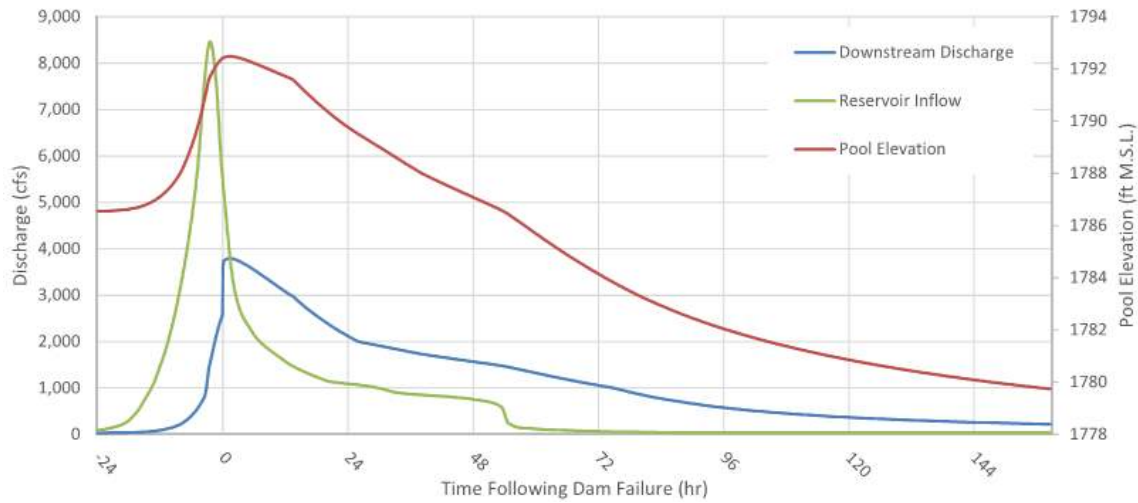
Figure K.6 – Stormy Day Dam Failure Hydrograph, SDF Inflow Hydrograph and Pool Elevation at Sixth Lake Dam site

The dam failure occurs when the water surface elevation reaches the peak SDF pool elevation. The peak SDF pool elevation occurs when the spillway (el. 1786.0 ft M.S.L.) and top of dam (el. 1790.9 feet M.S.L.) have already been overtopped and face a significant downstream tailwater created in part by the overtopping of the Route 28 culvert. As the dam breach widens, the resulting downstream flood wave is constrained by the tailwater. **Figure K.6** shows the hydrograph of inflow to the Sixth Lake Dam reservoir, the pool elevation, and the hydrograph of the dam discharge which includes the dam breach.
